## Endcap A Repair Log

November 14, 2006

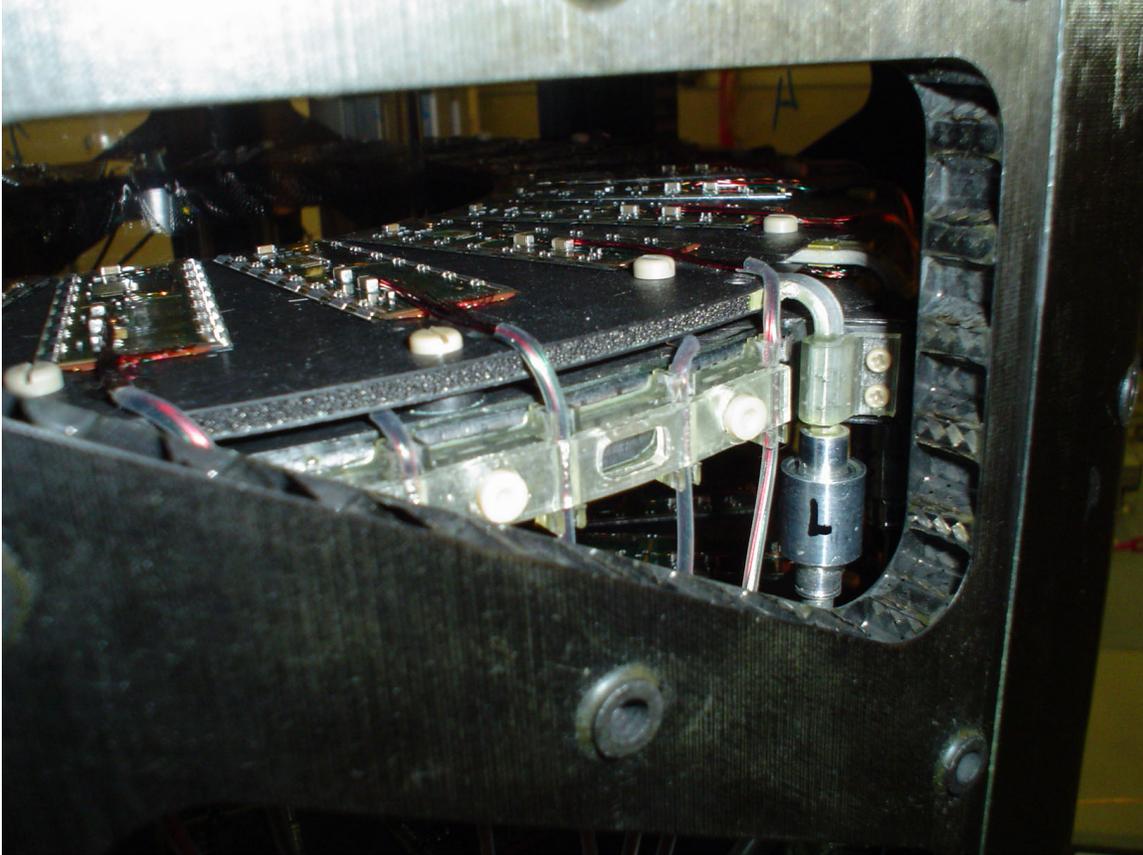
Try to setup to see if we can fix four fittings on endcap A. One with apparent largest leak is shown below

Leak check of exhaust region shows large leak. Baseline is high 8-scale and leak if large. Cannot tell if leak is at fitting or at weld/backfilled glue of sector pipe. Tried leak checking at capillary with baseline around  $1e-7$ . No evidence of leak but hard to see small leak on this scale..

We bubbled with 1bar overpressure with alcohol. Easy to see bubbles at fitting. Spent a few hours trying to figure out how to rotate nut. Finally attached round regular clamp to sector tube side and used hemostat to grab nut and rotate by hand. Took multiple tries.

Removed clamp. Lowered nut. Compressed with tool. Still leaks. Pressure again and look at bubbles. Tried tool multiple times. Moves bubbles around but still leaks.

Maurice gets his brass tool into space. Alas no picture of this. Tighten. Cannot see bubbles. Leak check. Good on mid-10 scale!! Checked other three fittings. Also good!

Clean threads and nuts. Greased. Torqued with forceps very roughly 5% of full turn. Can't loosen with two-finger pressure.

Pressurize to 4 bar abs and leak check. All tight to mid-10-scale!!!

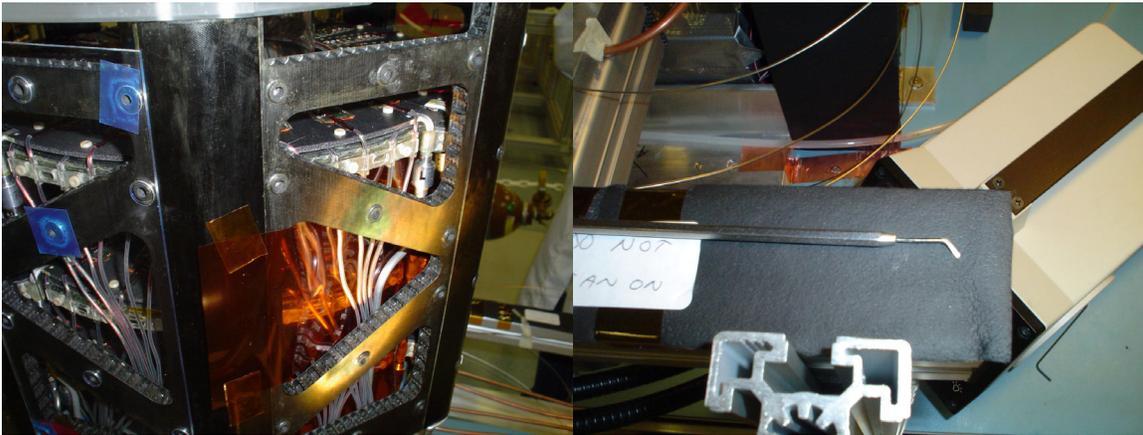
Kapton “debris guards added – see below. Tool for removing 5-minute epoxy

Glue easily removed with tool above. Glue fragment picked off with tweezers. Tried to rotate nut with fingers. It's tight! It seems to be torqued since we cannot untighten with two-finger, finger rotation. Decide to re-leak check.
